PHOTO INTELLIGENCE MEMORANDUM

SPECIAL INSTALLATION

GP/I-52

February 1955

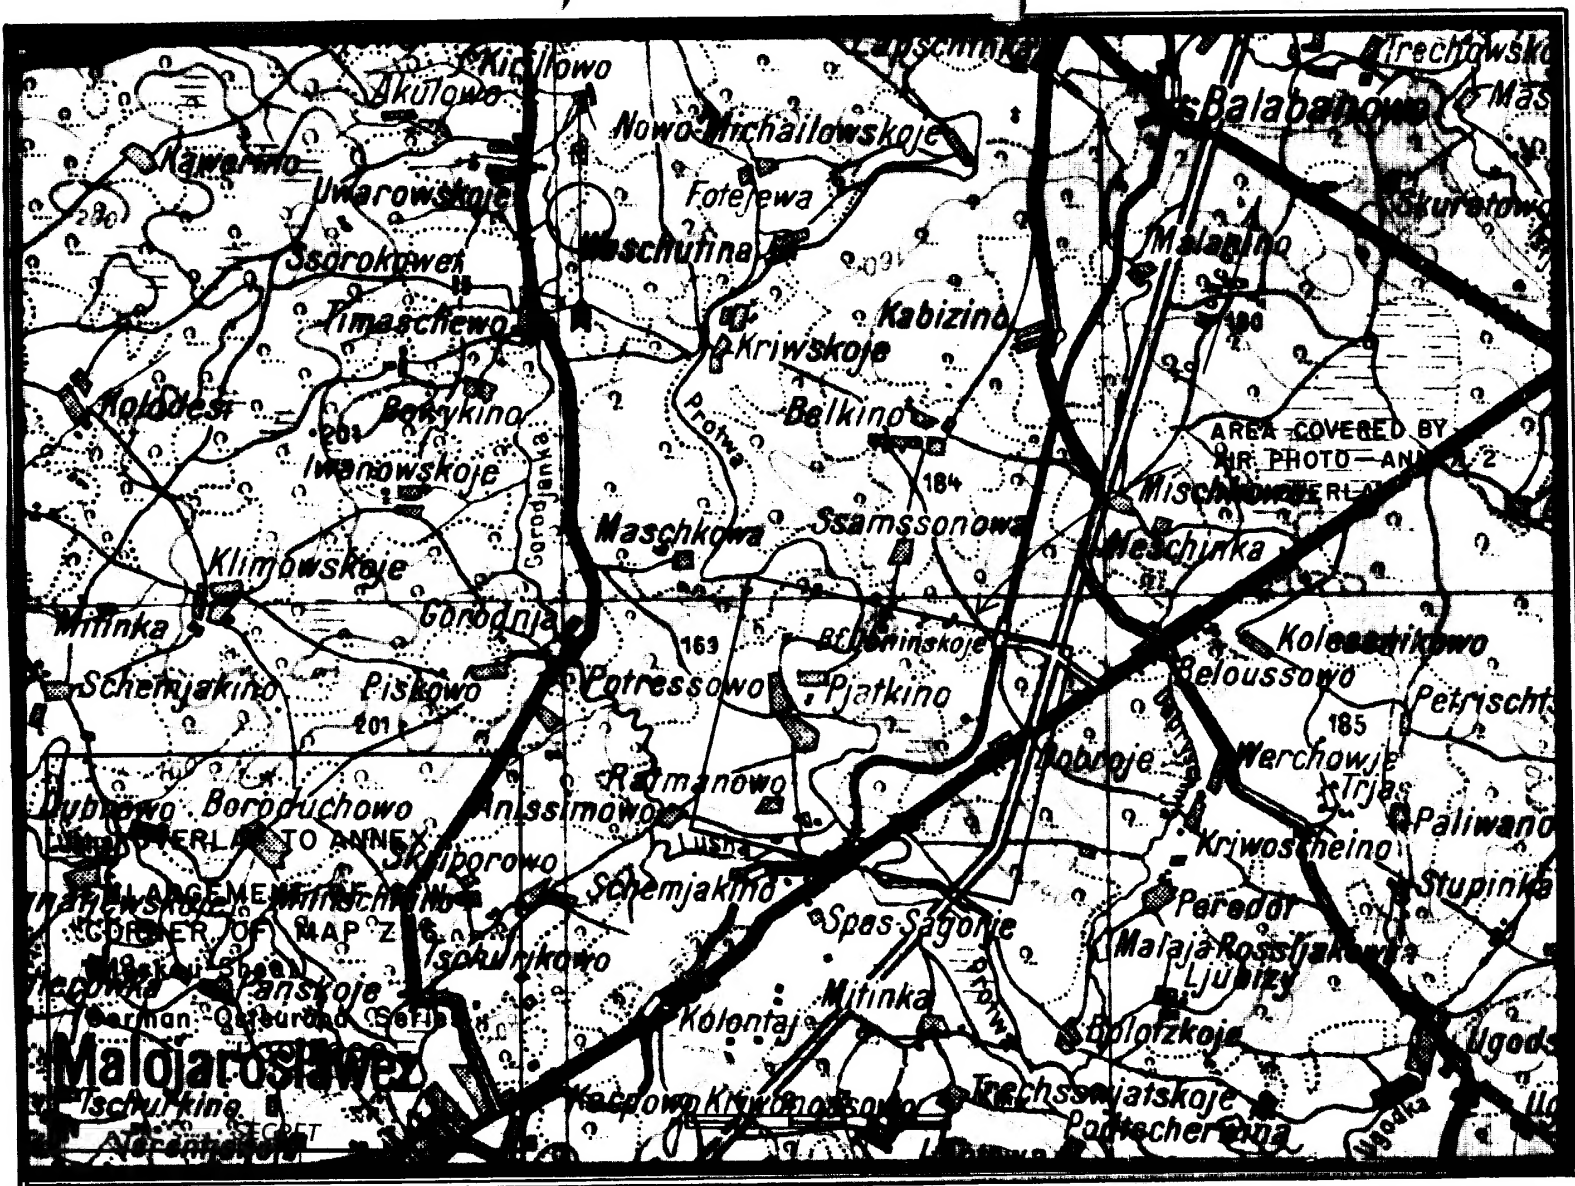
ANNEX 1

Annex 1. Consists of an enlargement of that portion of Sheet No. Z 56 that encompasses the area of concern and an orienting overlay indicating the area of cover of the aerial photograph (Annex 2).

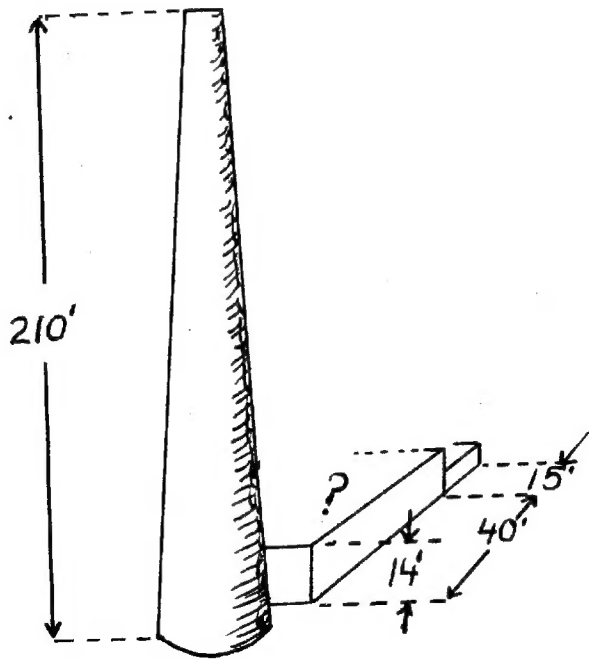
Bldg # 1

Annex 3. Consists of sketches of the buildings shown on the ground photography with approximate dimensions indicated. Note that buildings 4 and 5 appear to be almost identical in structure.
